Manhole Inspection Summary

Manhole # S05EE1015MH

Location Address: **3948 OAKFORD AVE**

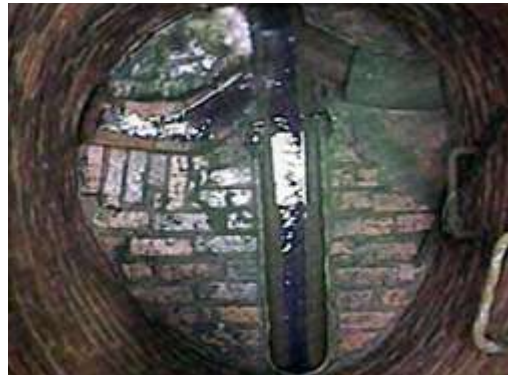
Top View

DEBRIS ON CHANNEL

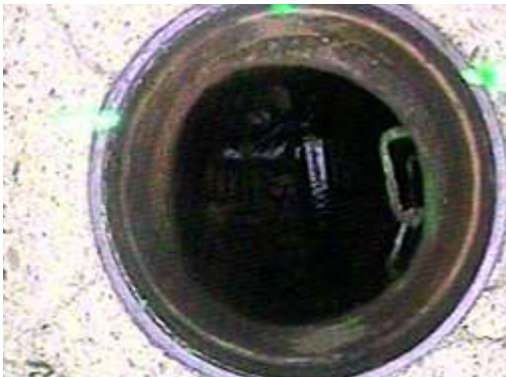
Top View

OFFSET CHANNEL

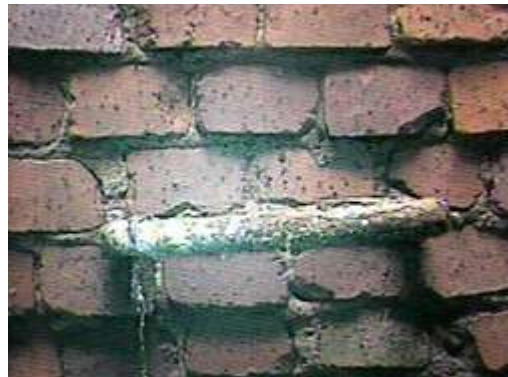
Defect 1

Steps Count: **5** Missing: **0** ☒ **Corroded**

CORRODED RUNG

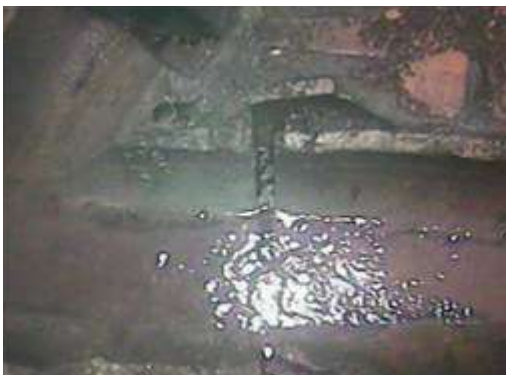
Defect 2

Condition: ☐ Sound ☒ **Cracked** ☐ Root Intrusion ☐ Deteriorated ☒ **Leaks** ☐ Debris

CHANNEL CRACKS AND LEAKS

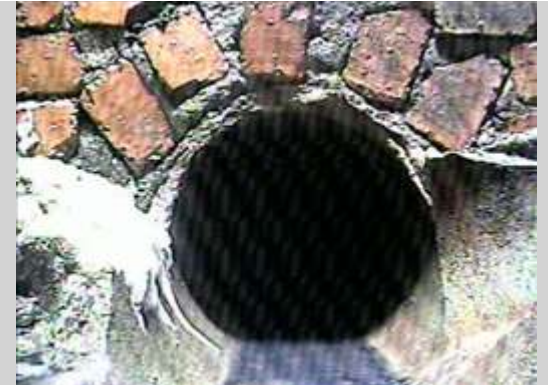
12 O'Clock Outflow

8 in. Circular Gravity Sewer
Pipe Out @ 12 O'Clock

Invert Depth: **8.96** (ft.) Flow Characteristics: **Slow**

Infiltration: **None** Pipe Seal Cond: **Sound**

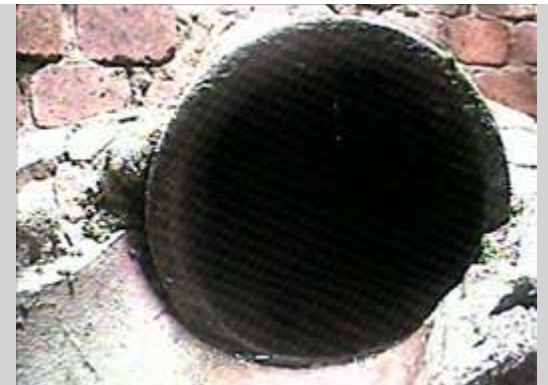
3 O'Clock Inflow

8 in. Circular Gravity Sewer
Pipe In @ 3 O'Clock

Invert Depth: **8.45** (ft.) Flow Characteristics: **Slow**

Infiltration: **None** Pipe Seal Cond: **Sound**

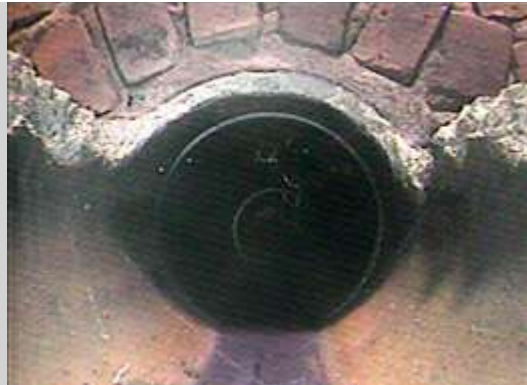
6 O'Clock Inflow

Invert Depth: **8.90** (ft.) Flow Characteristics: **Slow**

Infiltration: **None** Pipe Seal Cond: **Sound**

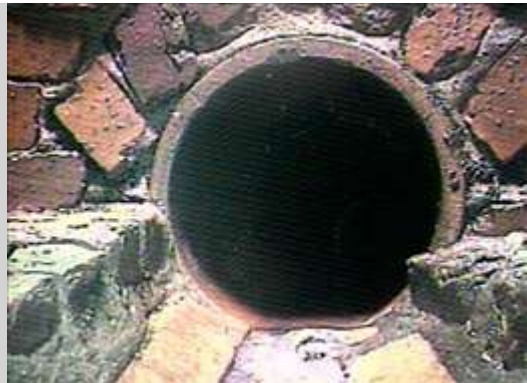
10 O'Clock Inflow

Invert Depth: **8.64** (ft.) Flow Characteristics: **Slow**

Infiltration: **None** Pipe Seal Cond: **Sound**
